ELIMINATOR[®] System Protects Historic Bridge Deck

GCP products integral to reconstruction project

Project	Charles Bridge, Prague
Client	Prague Municipality
Contractor	SMP CZ
Applicator	Helifix CZ
GCP Solutions	ELIMINATOR [®] Bridge Deck Waterproofing system, METASET [®] structural adhesive

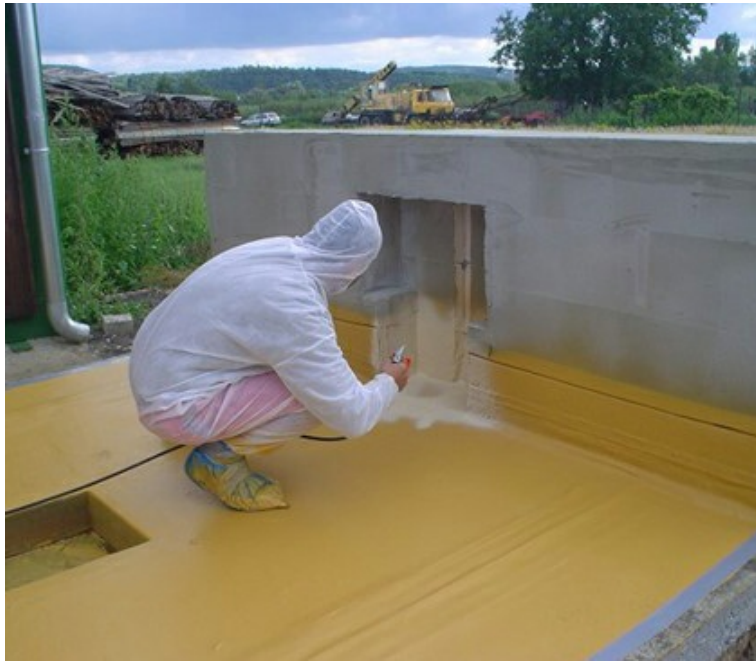
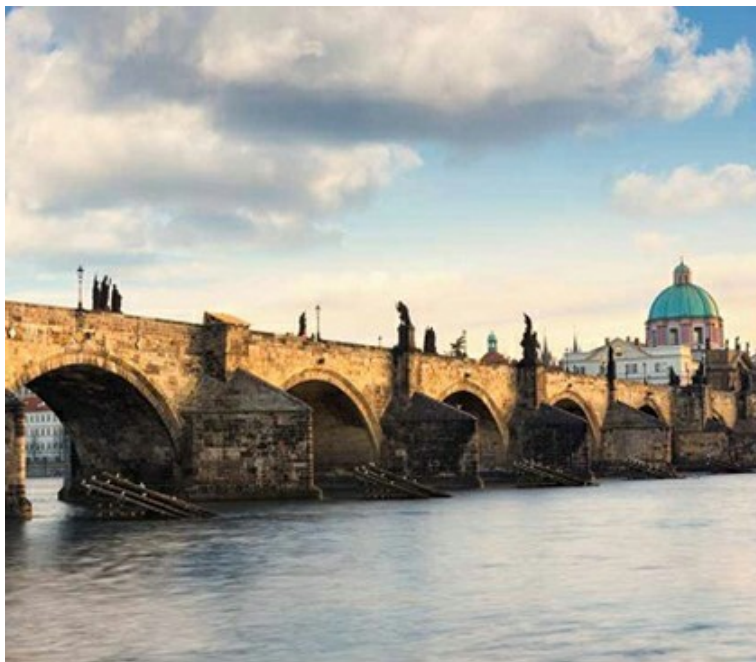
The granite paving, old concrete deck and previous waterproofing system were removed. Once the new concrete deck was in place and had been left to cure, a primer was applied to seal the concrete.

The ELIMINATOR[™] waterproofing membrane was then spray applied in two separate coats, each in a contrasting colour to provide a visual check to confirm the required thickness was achieved. The ELIMINATOR[®] system cures rapidly, enabling speedy progression of the project.
